**SPECIAL ENGINEERING SERVICES TO
ESTABLISH INSPECTION CRITERIA FOR
BEARINGS TO IMPROVE LIFE PREDICTION**

FINAL ENGINEERING REPORT

SwRI Project 15-4012

Warner Robins Air Logistics Command
Directorate of Materiel Management
Robins Air Force Base, Georgia 31093

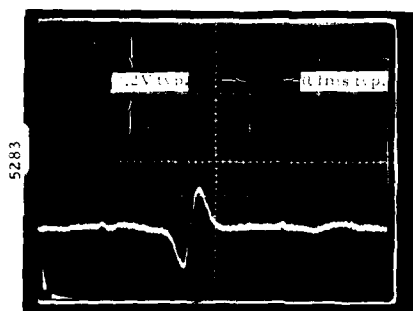
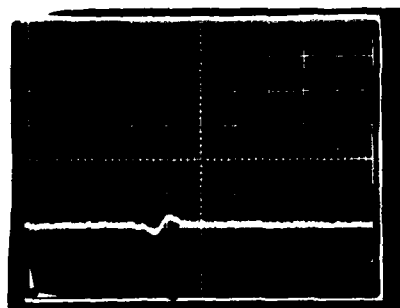
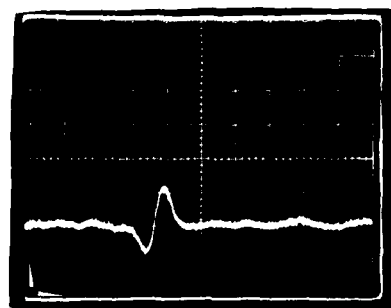
FIGURE 15. CIBLE RESULTS ON J57-#4 BEARING (S/N 219A-2)
 INNER RACE, NONLOADED HALF (S12052-1), 3761 HRS.
 SERVICE, VENDOR REWORKED.

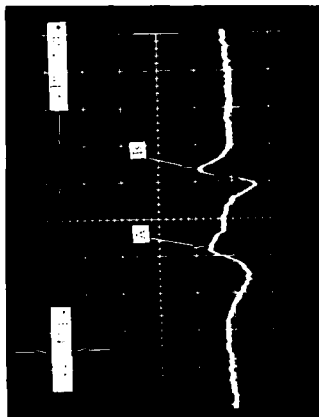
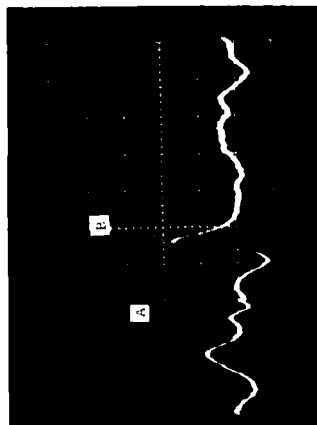
FIGURE 18. CIBL RESULTS ON J57-#2 BEARING S/N 144D-2 INNER RACE, LOADED HALF (S00762-3),
6965 HRS. SERVICE (VENDOR REWORKED) BEFORE AND AFTER ENDURANCE TESTING

Figure 23 summarizes metallurgical results in the regions of signatures A and B previously presented in Figure 18 from the inner race, loaded half of J57-#2 bearing, S/N 144D-2. Note the extensive material transformation present in the flaw region corresponding with the cracking (signature A, see Figure 18) as shown by photomicrographs B through E in Figure 23 as well as A and B of Figure 23A. It is pointed out that such extensive transformation is not evident in the flaw region corresponding with signature B (see Figure 18) as shown in photomicrographs A through D of Figure 23B.

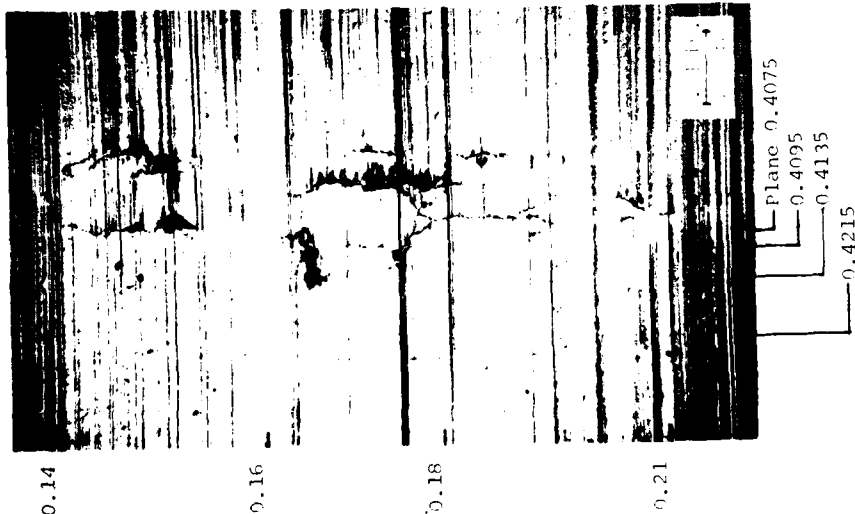
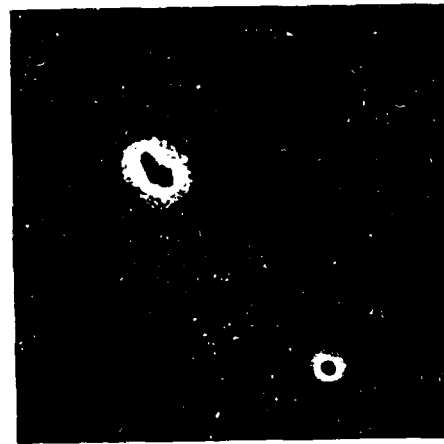
The presence of critical flaws corresponding with signatures and/or service-induced cracking have also been confirmed through metallurgical examinations. For example, Figure 22 summarizes the results of metallurgical investigations in the region of the extensive, service-induced crack network previously illustrated in Figure 8 of this report. The sectioning planes illustrated in photomicrographs B through F of Figure 22 are referenced to the sectioning plane locations indicated in photomicrograph A of the same figure. Even though the sectioning planes illustrated in Figure 22 are near one edge of the damaged region, note the significant flaws and subsurface cracking present; material transformation was also extensive in the region investigated.

FIGURE 22. METALLURGICAL EXAMINATION OF CRACK NETWORK ON J57-#2 BEARING S/N 144D-2),
INNER RACE, LOADED HALF AT BR2291 LOCATION (500762-3), (6965 SERVICE HOURS).

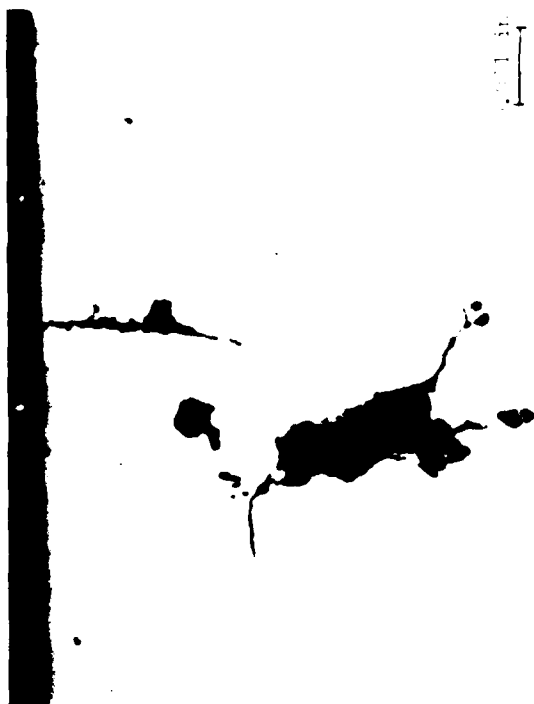
FIGURE 23B. METALLURGICAL EXAMINATION OF REGIONS CORRESPONDING TO SIGNATURES A AND B ON J57-#2 BEARING (S/N 144D-2), INNER RACE LOADED HALF (S00762-3) (continued)

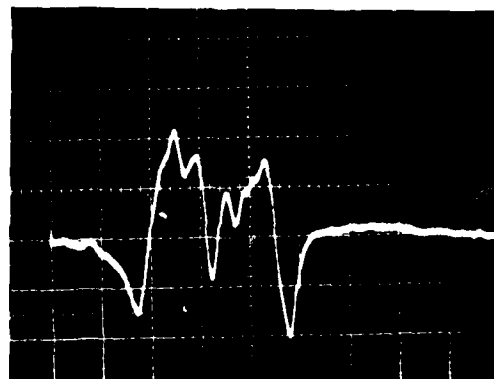
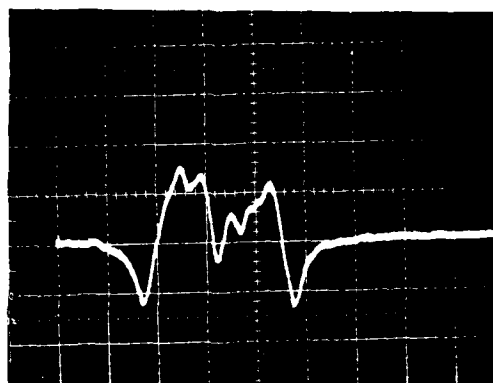
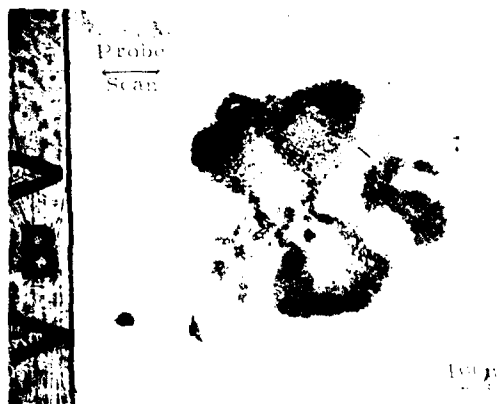
Figures 24 and 25 show the outstanding radial signatures obtained from surface damage in OALC-processed service balls. Figures 26, 27, and 28 show an inclusion, pitting and cracks and a substantial crack network with loss of material, respectively, from vendor processed bearings, apparently new balls. While the data presented above for balls is not from sampling a large part of the overall ball population, it does clearly show the extent of flaw conditions present in balls from serviceable bearings. Many other examples of signatures and corresponding flaws are presented in Appendix C.

FIGURE 24. CIBLE INSPECTION SIGNATURES AND SURFACE PHOTOMICROGRAPHS
SHOWING CORRESPONDING SURFACE FLAWS ON BALL WITH 3230 HRS.
SERVICE, J57-#4 BEARING S/N 9117-2 (Ball #20, Defects 1 and 2).

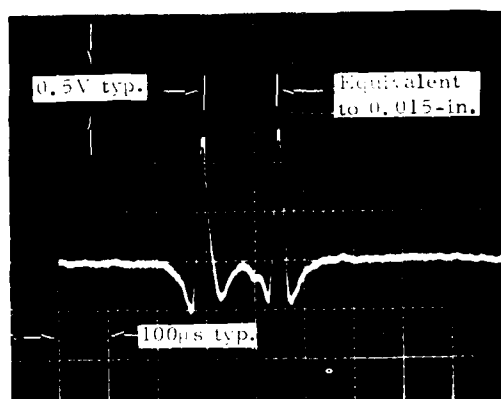
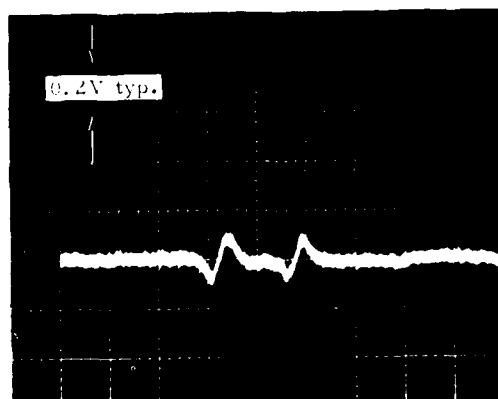
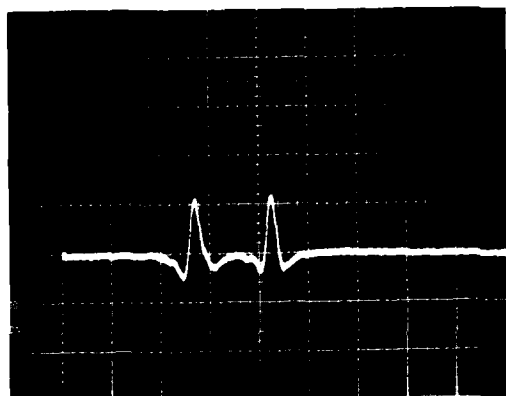
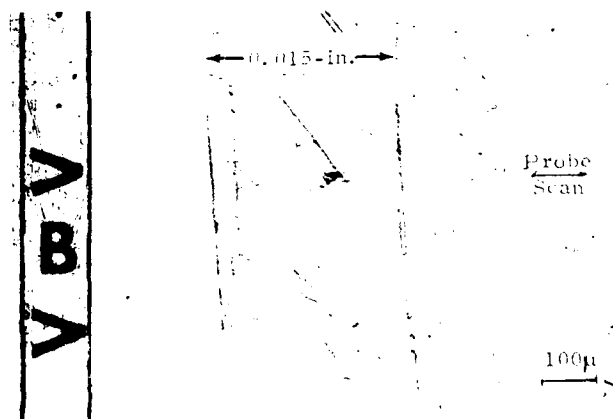
FIGURE 1. THERMAL INSPECTION SIGNATURES AND CORRESPONDING SURFACE PHOTO MICROGRAPH SHOWING GOUGES ON BALL WITH 4230 HRS SERVICE, 357-#4 BEARING S/N P9117-2 (Ball #30, Defect #3).

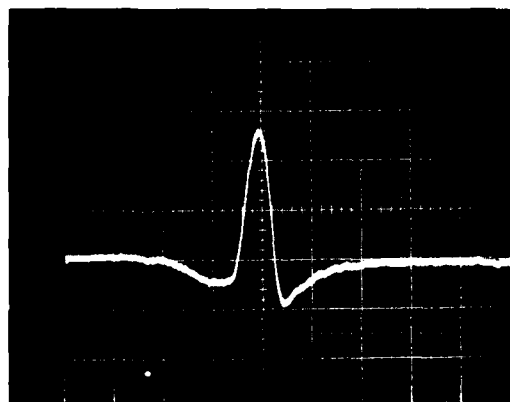
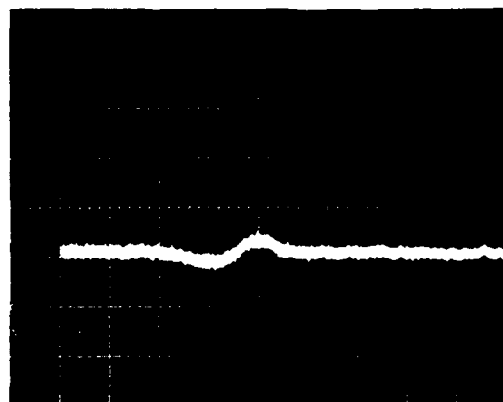
FIGURE 2. CIBLE INSPECTION SIGNATURES AND CORRESPONDING SURFACE PHOTOMICROGRAPH SHOWING DENT ON BALL WITH 3230 HRS SERVICE, J57-#4 BEARING S/N P9117-1 (Ball #9).

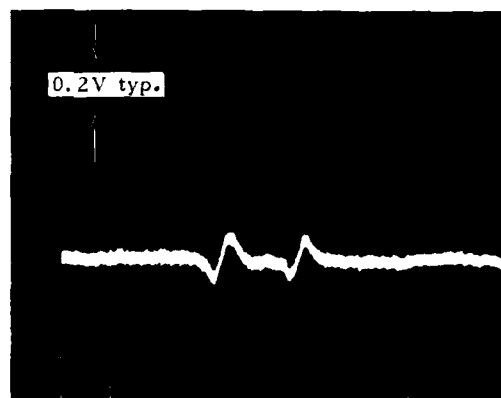
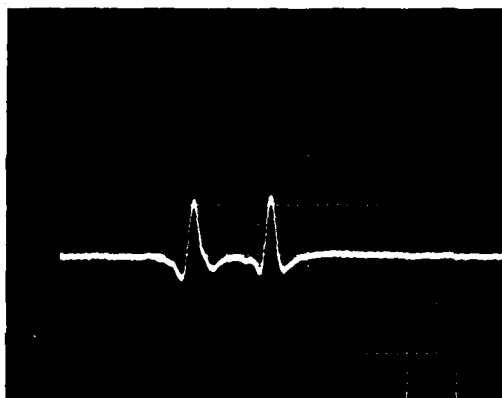
separation between the resulting radial signatures. These gouges have sufficient depth to produce small, circumferential signatures also (see Records C and D in Figure 4). Figure 5 shows pit and gouge type defects in two other service balls. Again, note the large radial signatures; the small circumferential, high field (CH) signature in the case of the gouge indicates that this flaw does not have significant depth.

FIGURE 4. CIBLE INSPECTION SIGNATURES AND CORRESPONDING SURFACE PHOTOMICROGRAPH SHOWING GOUGES ON BALL WITH 3230 HRS SERVICE, J57-#4 BEARING S/N P9117-2 (Ball #20, Defect #3).

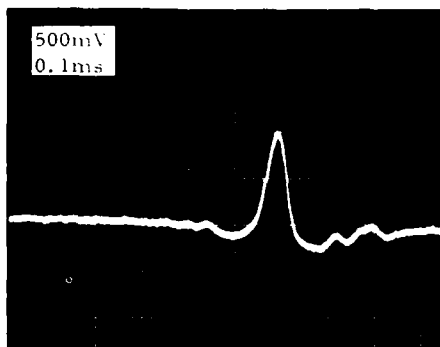
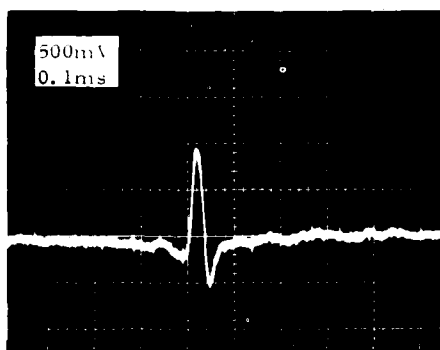
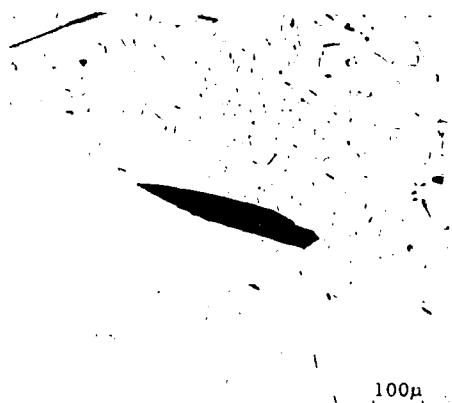
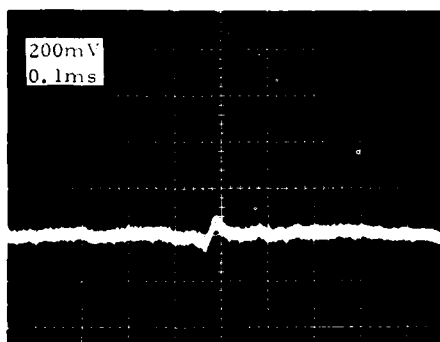
Ball, J57-#4 Bearing, S/N 476T-1, 3555 hrs. service (Ball #3, A00028F)

Ball, J57-#4 Bearing, S/N 9427-2, 1059 hrs. service (Ball #10, S11952)

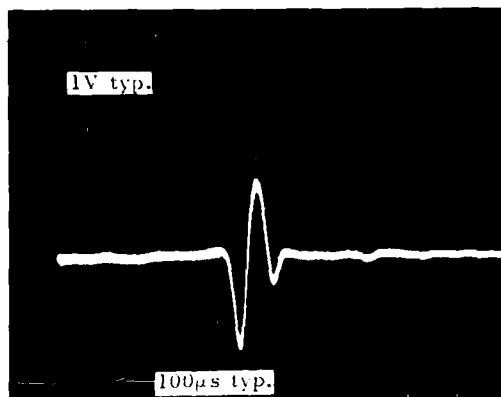
Figure 6 illustrates the magnetic response obtained from a surface inclusion pit (see surface photomicrograph E). The surface finish surrounding the pit in Figure 6 is typical of that observed for the new balls examined from reworked bearings. A comparison of the surface finish in Figure 6 with that for the service ball in Figure 1 indicates that the multitude of fine, short and long scratch lines are typical of balls with service. The data in Figure 7 shows evidence of another inclusion pit with significant depth since a relatively large circumferential high field signature is obtained (see record C). Similarly, the data in Figure 8 shows a large group of pits from which two outstanding radial signatures are obtained; the smaller circumferential signature indicates these pits to be shallower in depth than the one previously shown in Figure 7. A significant group of pits in still another new ball is illustrated in Figure 9. Gouges in new balls are also evident as illustrated in Figures 10 and 11; very large radial signatures are evident in both cases.

FIGURE 10. CIBLE INSPECTION SIGNATURES AND CORRESPONDING SURFACE PHOTOMICROGRAPH SHOWING ANOMALY ON NEW BALL FROM VENDOR REWORKED J57-#4 BEARING S/N 9191-1, 1500 HRS (Ball #4, S11911).

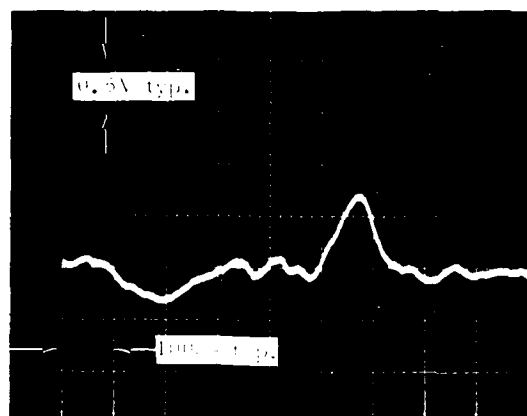
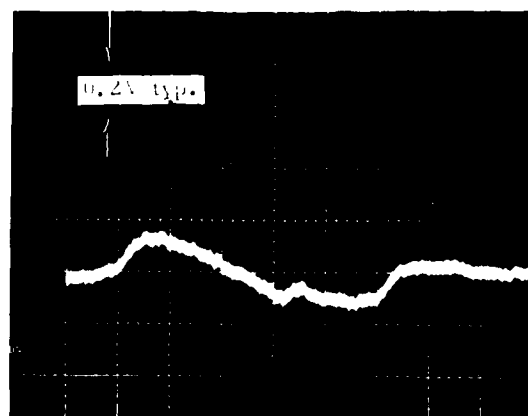
As might be anticipated, essentially no evidence of indentations were observed in the new balls visually examined. Startling evidence, however, was obtained showing large-scale cracking and material loss in two new balls from one bearing (S/N395-2) as illustrated in Figures 12 and 13. The radial and circumferential signatures presented in Figure 12 are typical of those previously described as unusual, "poor shape" signatures (note the broad, opposite polarity of the CH signature and the broad, complex-shaped RH signature with a small amplitude RL signature). Examination of many regions corresponding to "poor shape" signatures did not yield visual evidence at the surface of flaw conditions similar to that illustrated in the photomicrographs at the bottom of Figure 12. Note the even more significant material loss and extensive cracking evident in case of the flaw illustrated in Figure 13 and corresponding magnetic perturbation response (typical of that obtained from inclusions and gouges); the complex CH signature shape is attributed to the complex nature of the flaw. It is anticipated that the flaw illustrated in Figure 13 resulted from the heat treating process, possibly in combination with an extended inclusion(s). As will be shown next in this section, the Barkhausen signatures from this ball (Ball #3 in Bearing S/N 395-2) also exhibited unusual Barkhausen signatures.

FIGURE 12. CIBLE INSPECTION SIGNATURES AND CORRESPONDING SURFACE PHOTOMICROGRAPHS SHOWING PITS AND CRACKS ON NEW BALL FROM VENDOR REWORKED J57-#4 BEARING S/N 395-2, 4362 HRS (Ball #11, S11672).

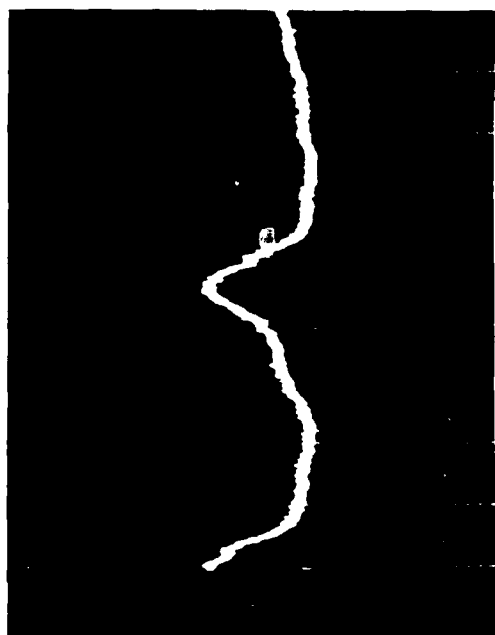
Typical Barkhausen signature shapes obtained from service and new balls are illustrated in Figure 14. The Barkhausen signatures illustrated in Records C and D of Figure 14 are typical of those observed from service balls. The signatures illustrated in Records A and B of Figure 14 are dominantly typical for new balls, although, signatures Type C and D were also observed in the case of the new balls. Significantly, Figure 15 illustrates the Barkhausen signatures obtained from four new balls on Bearing S/N 395-2. Note the leading edge signature feature, as pointed out by the arrow in each case, which is not evident in any of the Barkhausen signatures previously illustrated in Figure 14. Furthermore, the signature shown in Record A of Figure 15 was obtained from the ball containing the extensive crack network, see Figure 13. From the data presented in Figures 12, 13, and 15 the entire ball complement for Bearing S/N 395-2 is questionable (in addition, the ball complement in the mating duplex Bearing S/N 395-1 is also suspect). It is possible that many other balls from the same lot of balls containing those in Bearing S/N 395-2 are also suspect, however, SwRI does not have adequate information for this type of traceability.

FIGURE 14. TYPICAL BARKHAUSEN SIGNATURES FROM J57-#4 MAIN SHAFT BEARING BALLS.

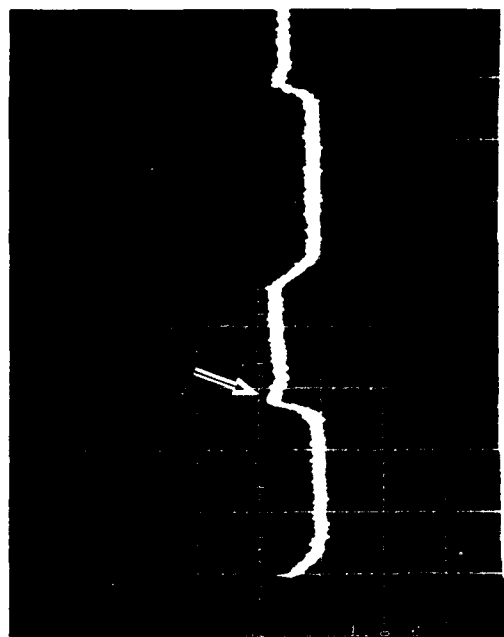
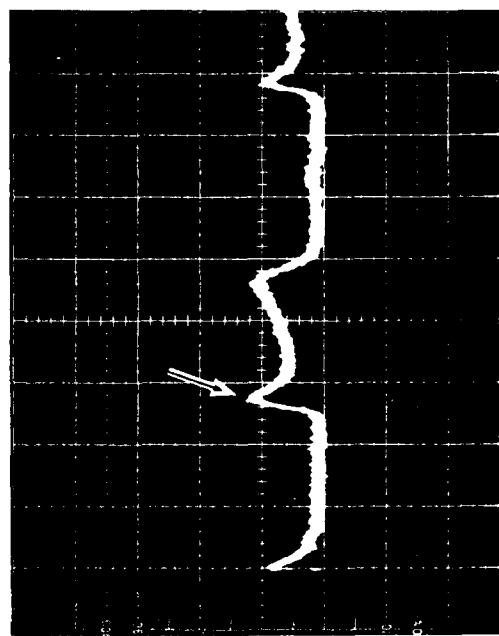
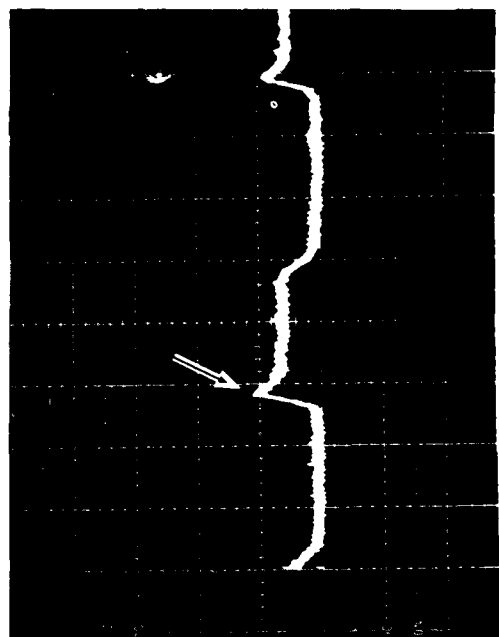
FIGURE 15. BARKHAUSEN SIGNATURES FOR FOUR BALLS FROM J57-#4 VENDOR REWORKED BEARING
S/N 395-2 (S11672), 4362 HRS.

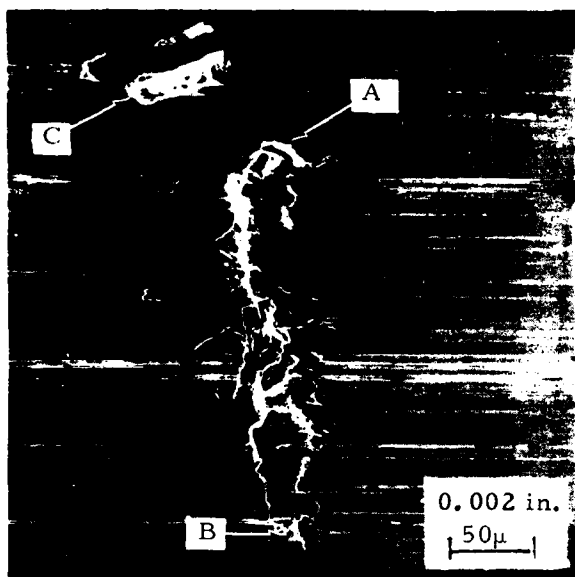
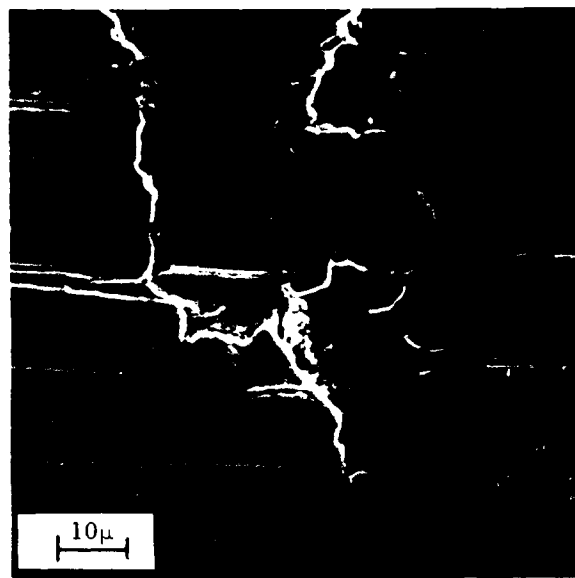
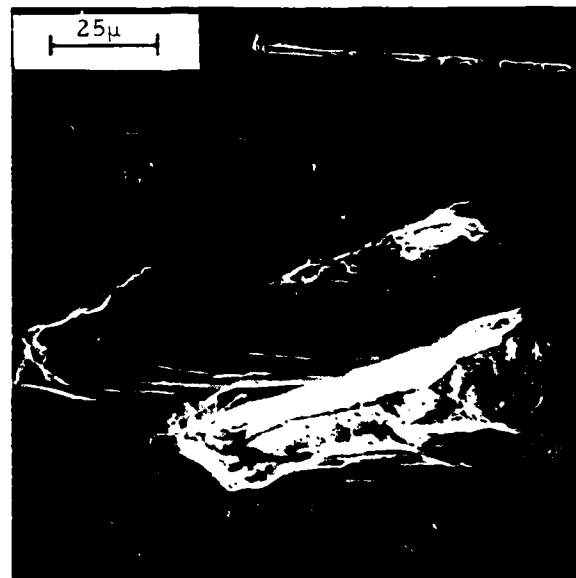
FIGURE F3. SCANNING ELECTRON MICROSCOPE (SEM) PHOTOGRAPHS OF SURFACE IMPERFECTION (Replica) AT 0004-4851, J57-#2 BEARING (S/N B1274-2) INNER RACE (Reworked Bearing).

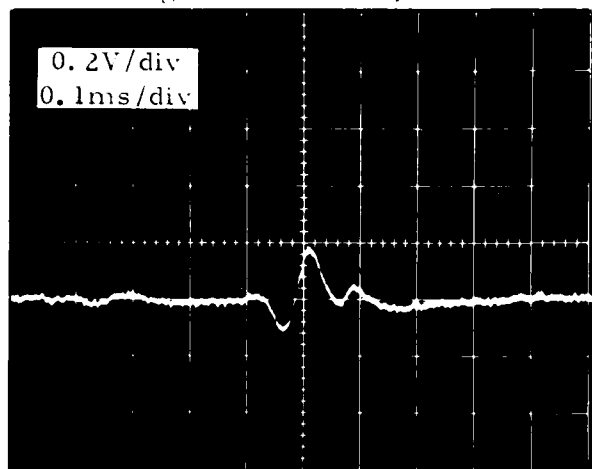
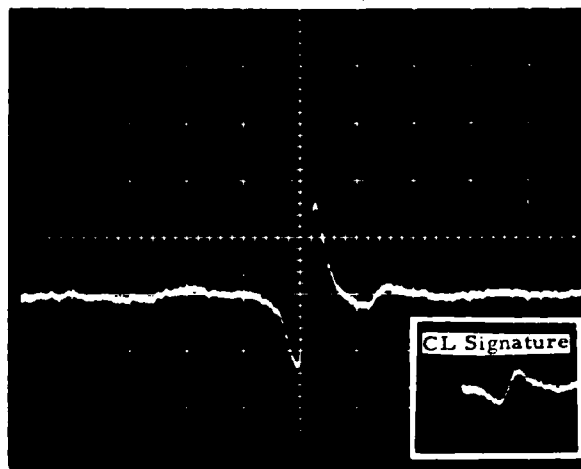
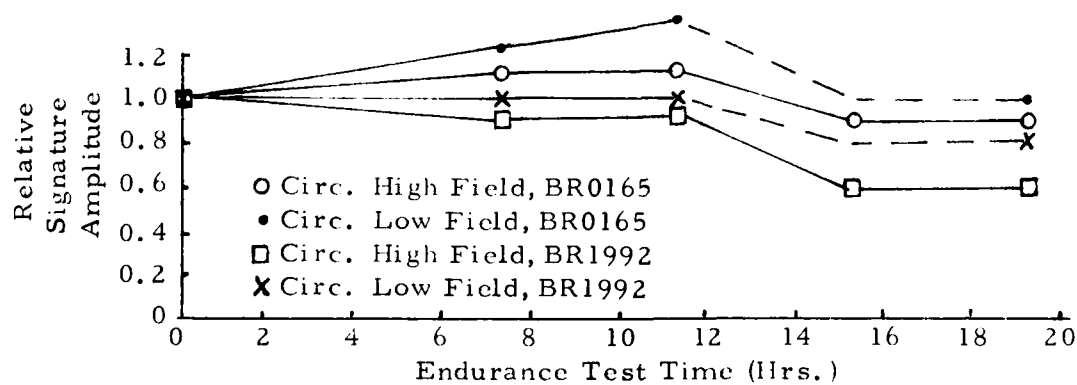
| Test Results | Prior Signature | Test Data Hrs - Stress | Bearing Type | Remarks | AF S/N (SwRI No.) | Test Ref. No. |
|---|---|---|---|---|---|---|
| Spall | CH, 0009-0165 | 26.2-332 ksi | J57-#4 | Inner race, NLH; 5678 hrs. service | 748A-1 (S10981) | 3 |

FIGURE F6. MAGNETIC PERTURBATION CIRCUMFERENTIAL FLUX SIGNATURES AT FLAW LOCATIONS 0009-0165 AND 0010-1992 AS A FUNCTION OF ENDURANCE TEST TIME, J57-#4 BEARING S/N 748A-1, INNER RACE S10981(1).

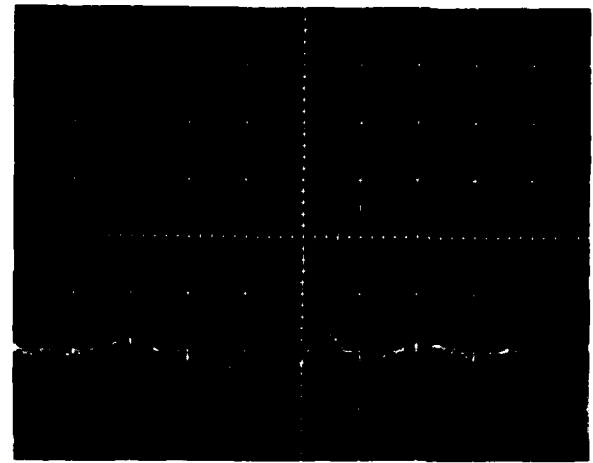
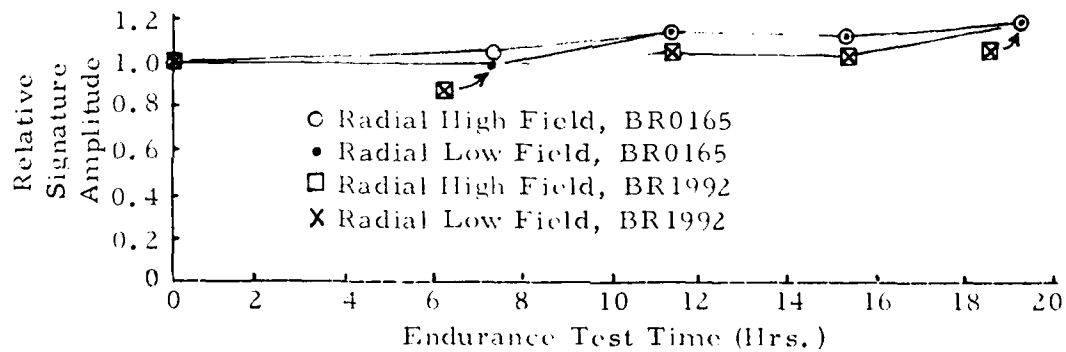
FIGURE F7. MAGNETIC PERTURBATION RADIAL FLUX SIGNATURES AT FLAW LOCATIONS 0009-0165 AND 0010-1992 AS A FUNCTION OF ENDURANCE TEST TIME, J57-#4 BEARING S/N 748A-1, INNER RACE S10981(1).

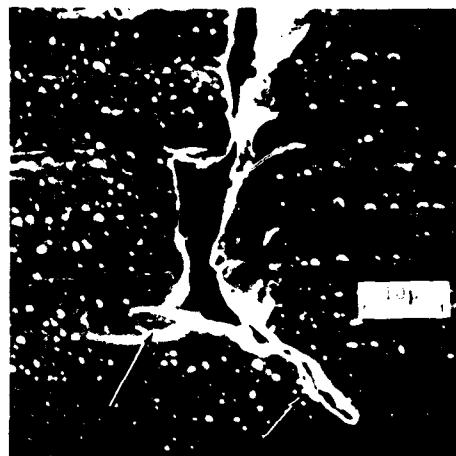
Arrows indicate regions of crack
progression and material loss.

FIGURE F10. REPLICATION (SEM) RESULTS AT 26.2 HRS ENDURANCE TEST
TIME IN VICINITY OF FLAW SIGNATURE AT 0010-1992, J57-#4
BEARING (S/N 748A-1 INNER RACE S10981(1) (5678 hrs., reworked)).

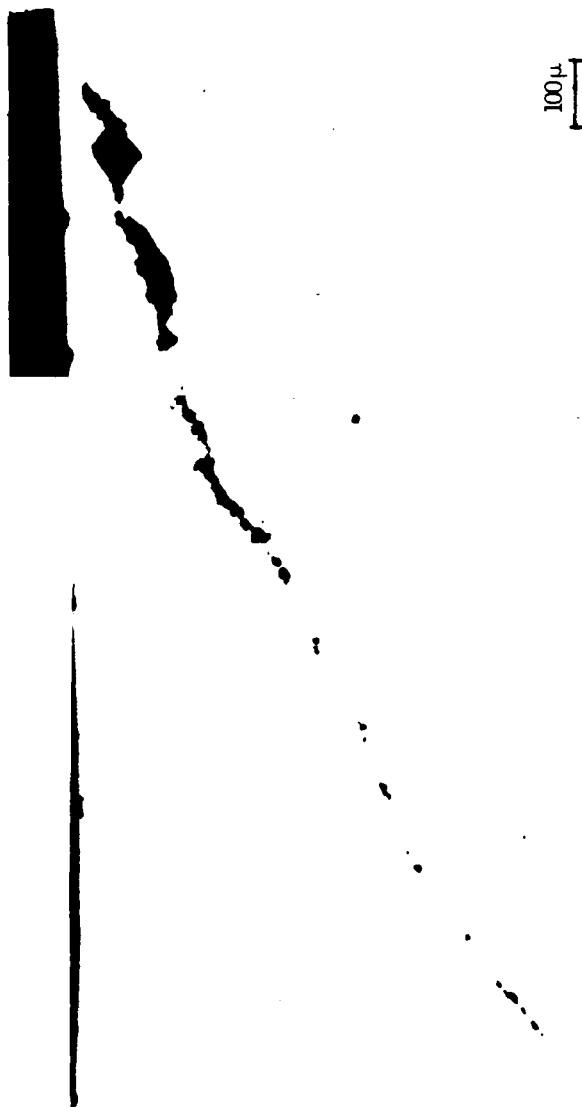
Photomicrograph 100 X (Plane 0.4328)

FIGURE F15. J57-#4 BEARING, INNER RACE, LOADED HALF
S/N 1325-2 (S10782-3) BR 4390, ST13

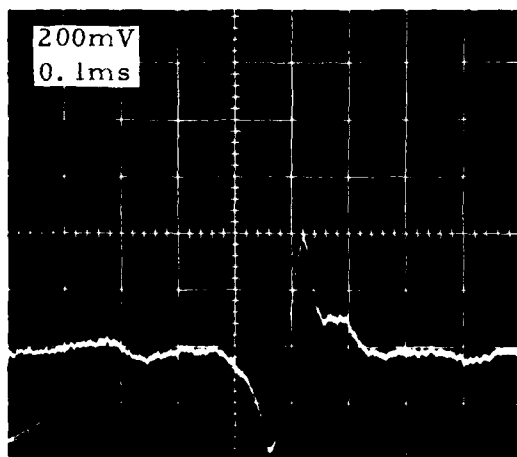
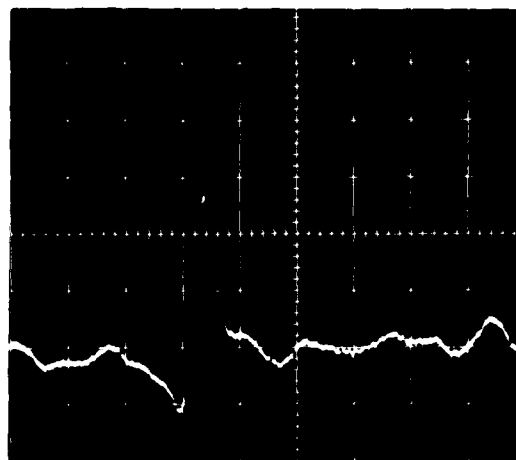
FIGURE F17. CIBLE RESULTS ON J57-#2 BEARING (S/N 1440-2) INNER RACE, LOADED HALF [S00762(3)] (6965 hrs. service - Vendor reworked bearing, accepted by Air Force as serviceable).

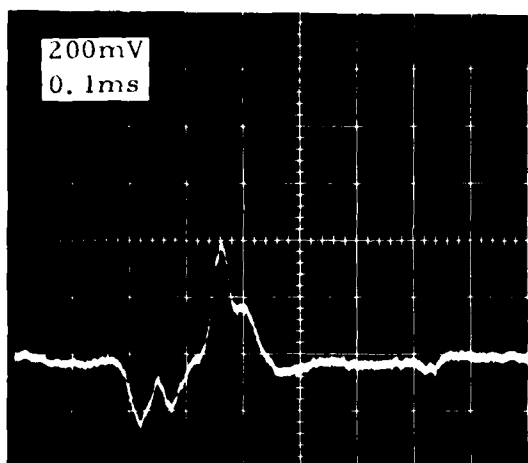
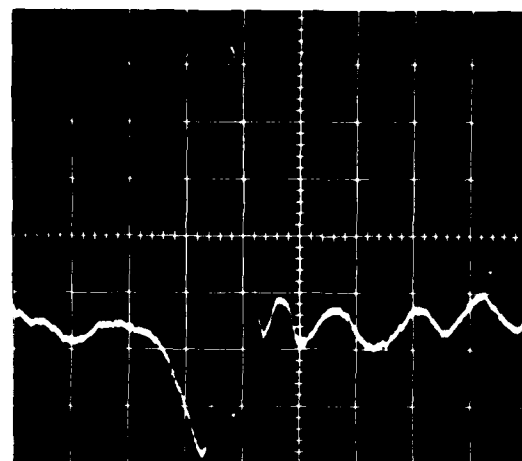
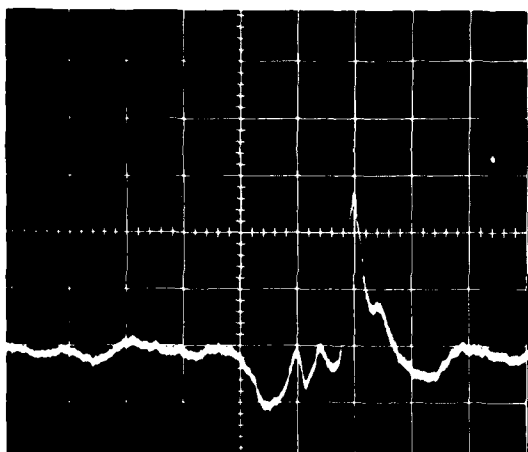
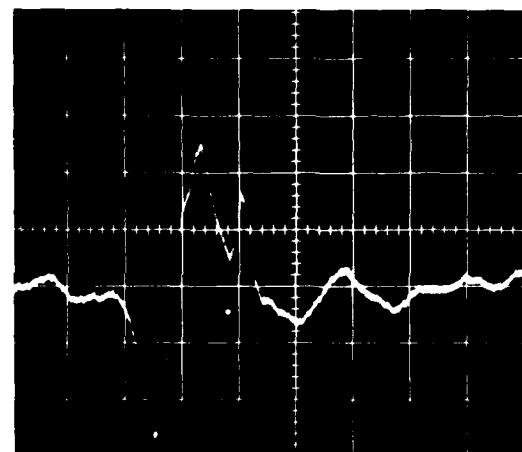
FIGURE F18. CIBLE RESULTS ON J57-#2 BEARING (S/N 1440-2) INNER RACE, LOADED HALF [S00762(3)] (6965 hrs. service - Vendor reworked bearing, accepted by Air Force as serviceable).

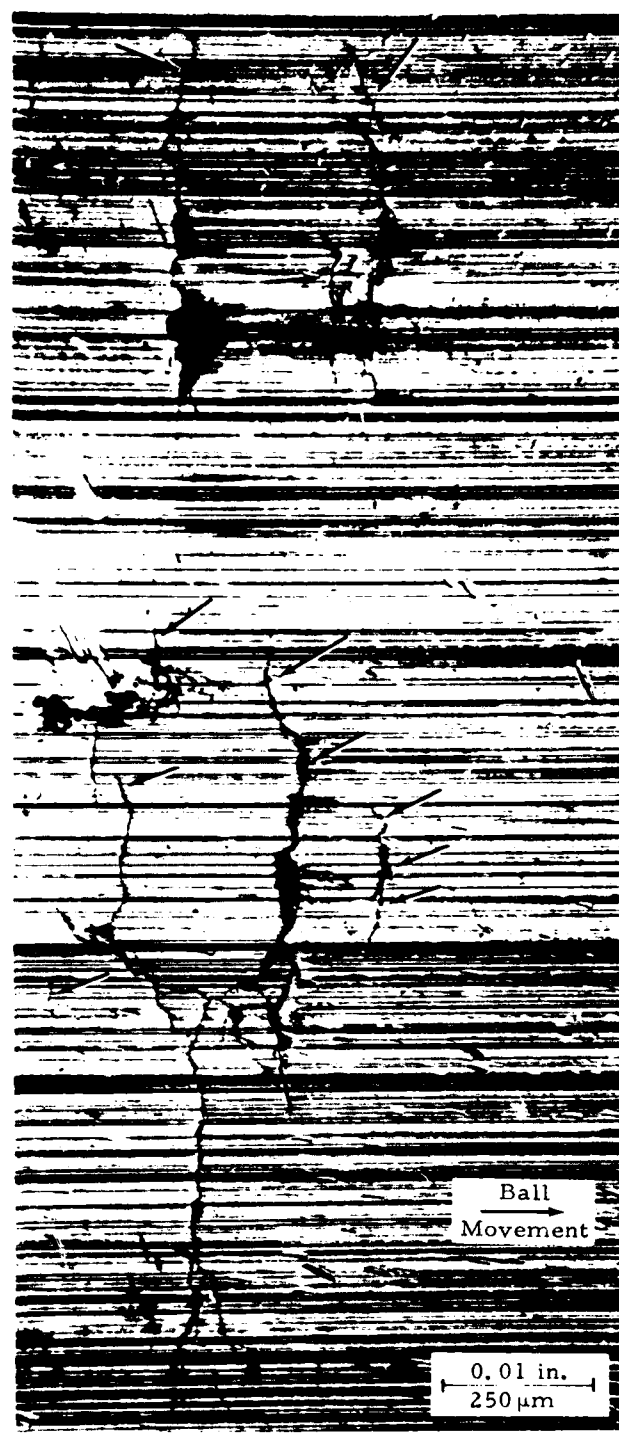
Small arrows point out regions of crack propagation.

FIGURE F20. SURFACE PHOTOMICROGRAPHS SHOWING CRACK NETWORK "BEFORE" AND "AFTER" 1 HR ENDURANCE TEST [S00762(3)].

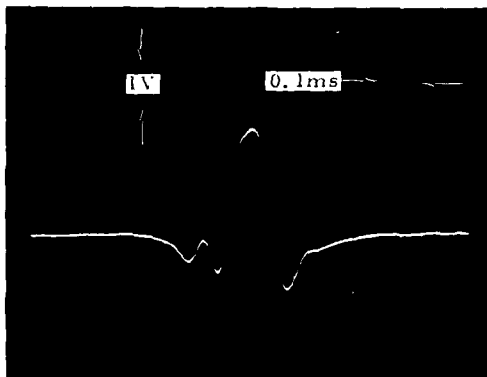
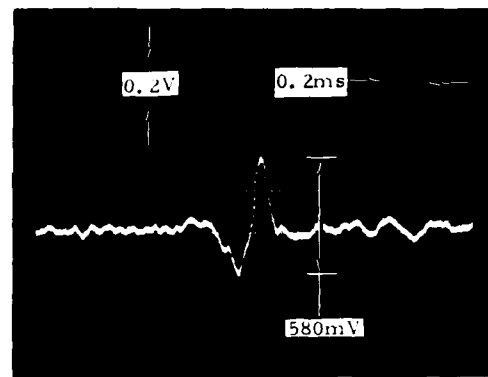
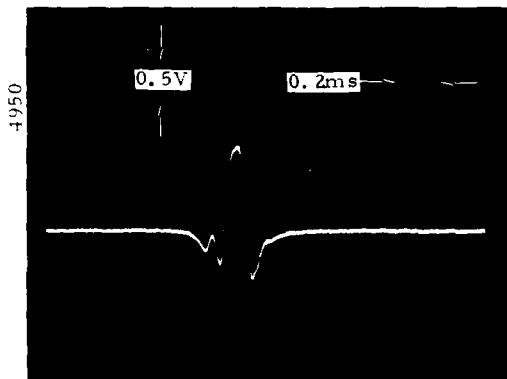
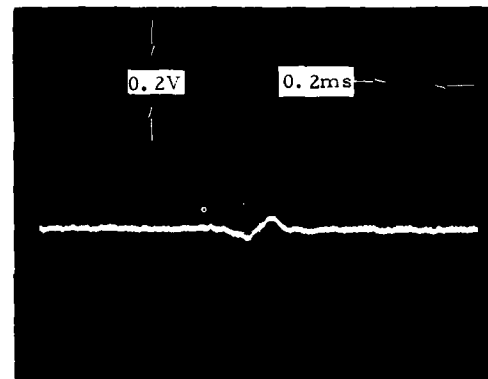
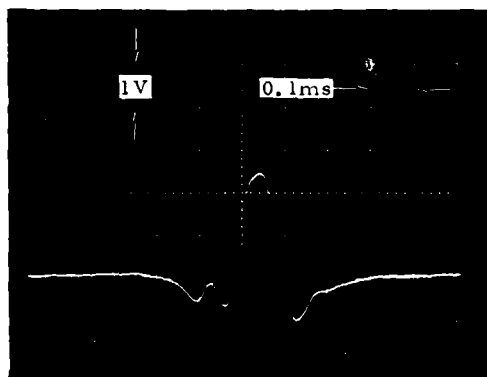
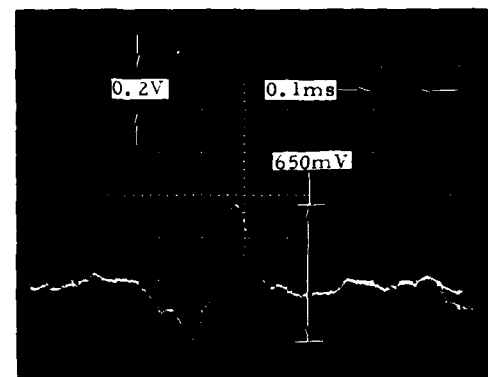
FIGURE F21. MAGNETIC PERTURBATION SIGNATURES AT TWO ENDURANCE TEST INTERVALS FROM LARGE SURFACE FLAW AT 0006+18 IN J85-#2 BEARING S/N A4230, INNER RACE, NONLOADED HALF (1133 hrs. service time) (S30211).

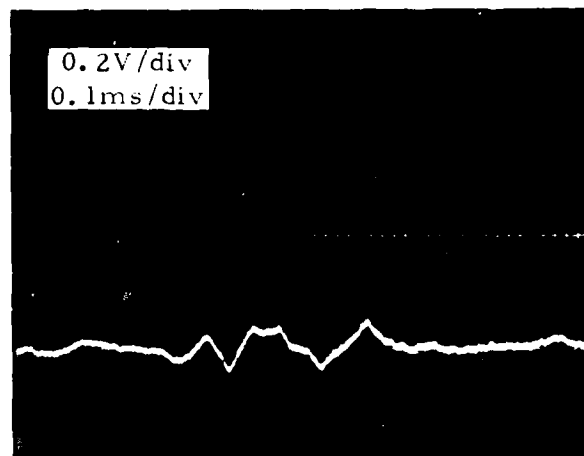
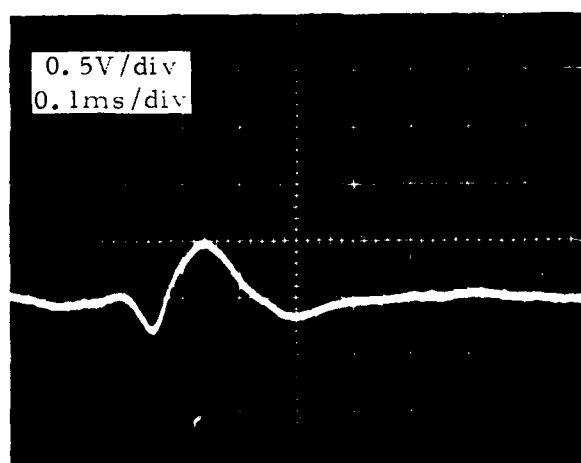
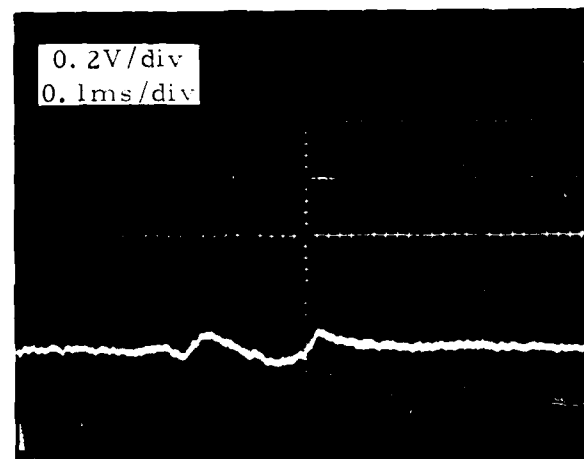
(BR 1288, ST0013+06)

FIGURE F23. MAGNETIC PERTURBATION SIGNATURES FROM SERVICE INDUCED CRACK NETWORK AT0013-1288 IN J57-#4 BEARING S/N 6857-1, INNER RACE LOADED HALF S11281(3) (1668 hrs. service, Vendor reworked).

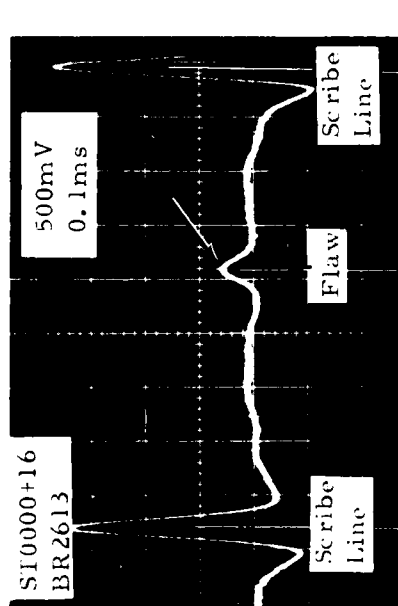
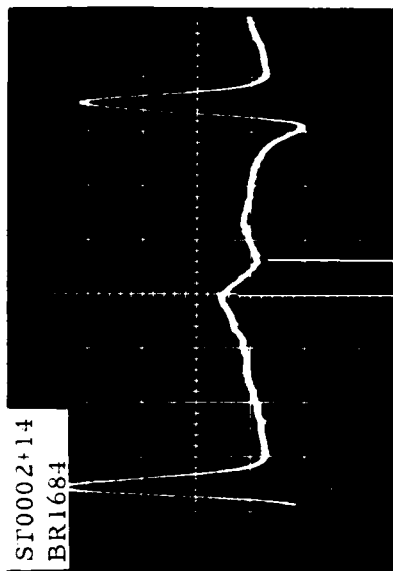
FIGURE F30. MAGNETIC PERTURBATION RADIAL SIGNATURE RECORDS AND SURFACE PHOTOMICROGRAPHS ILLUSTRATING METHOD FOR ACCURATELY DETERMINING FLAW SIGNATURE LOCATIONS ON J57-#4 BEARING (S/N 141C-1) INNER RACE S10071(2) (reparable bearing, 7946 hrs. service).

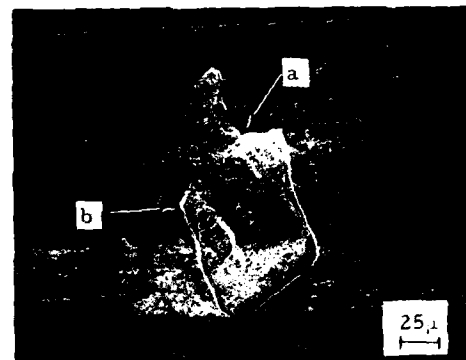
FIGURE F31. REPLICATION AND METALLURGICAL SECTIONING RESULTS FOR
SURFACE IMPERFECTION AT 0001-2613, J57-#4 BEARING INNER
RACE S/N 141C-1 REPARABLE REJECT S10071(2).

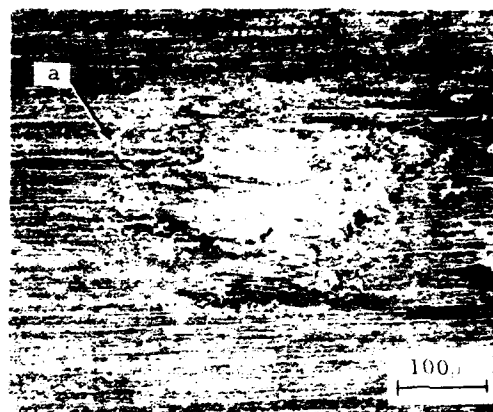
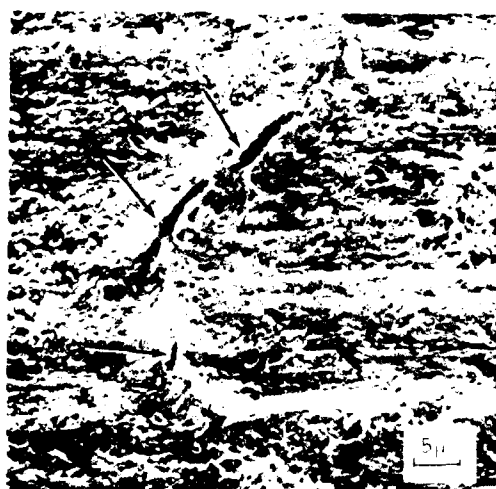
FIGURE F32. REPLICATION AND SECTIONING RESULTS FOR SURFACE IMPERFECTION
AT 0003-1684, J57-#4 BEARING (S/N 141C-1) INNER RACE S10071(2)
(Reparable Reject, 7946 Hrs.)

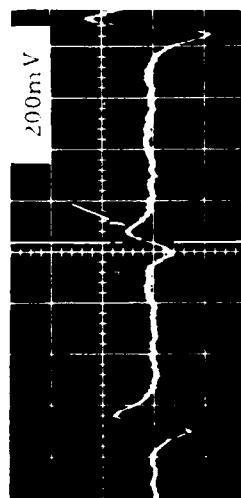
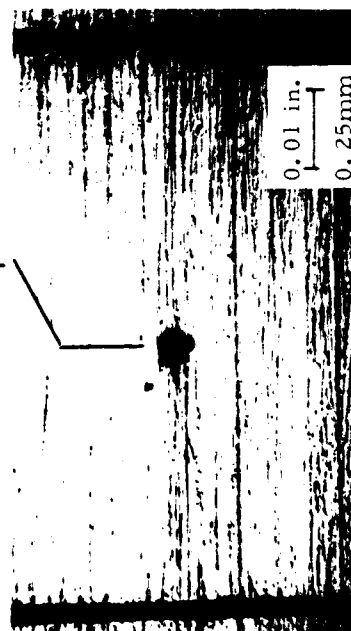
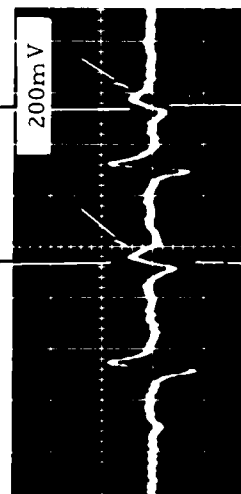
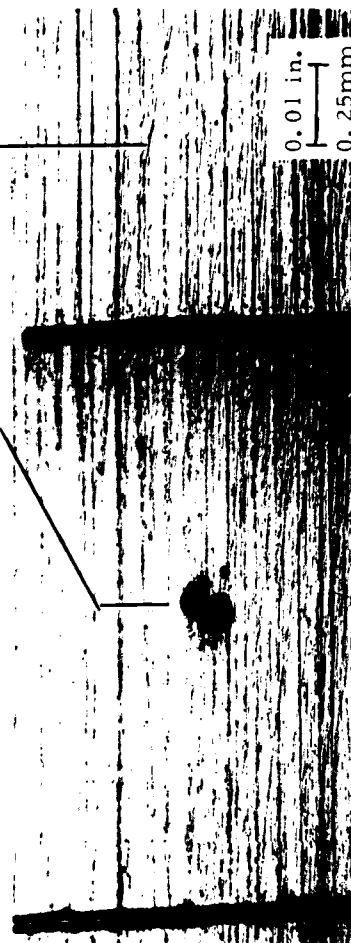
FIGURE F34. MAGNETIC PERTURBATION RECORDS AND SURFACE PHOTOMICROGRAPHS ILLUSTRATING
CORRESPONDING LOCATIONS OF SIGNATURES ON J57-#4 BEARING (S/N 427C-1) INNER
RACE S10141(3) (reparable bearing, 8337 hrs. service after rework).

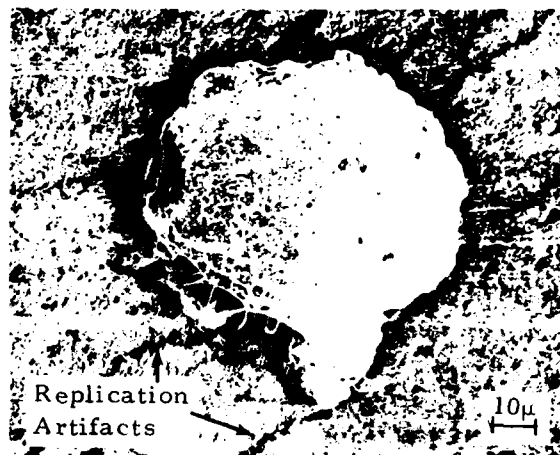
A. Surface Photomicrograph $\sim 100X$

B. Magnified View ($\sim 600X$) of Surface (SEM)
(after 2% nital etch)

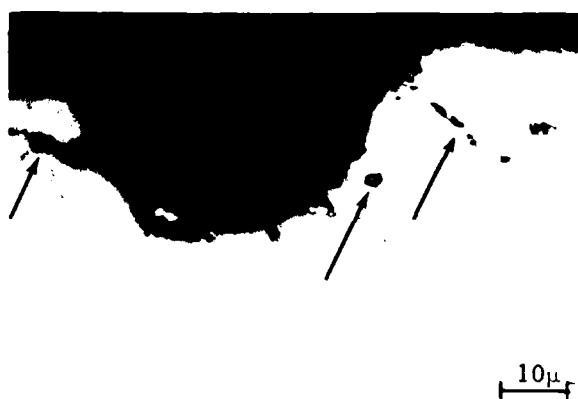
C. Section Plane 0.2951 $\sim 500X$

D. Section Plane 0.2951 $\sim 1000X$

E. Section Plane 0.2941 500X

F. Section Plane 0.2928 500X

FIGURE F35. REPLICATION AND METALLURGICAL SECTIONING RESULTS FOR
SURFACE INCLUSION PIT AT 0013-2818, J57-#4 BEARING
(S/N 427C-1) INNER RACE S1014(3) (8337 hrs. after rework,
reparable).

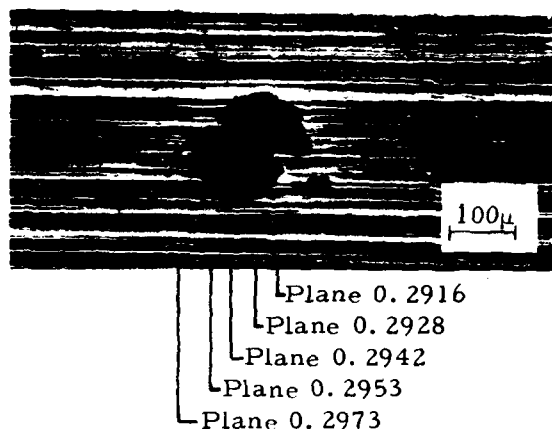
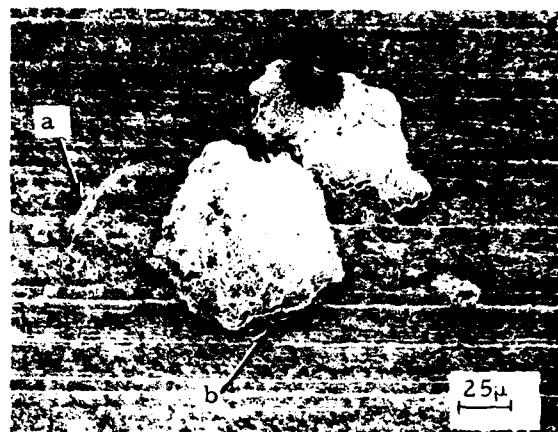
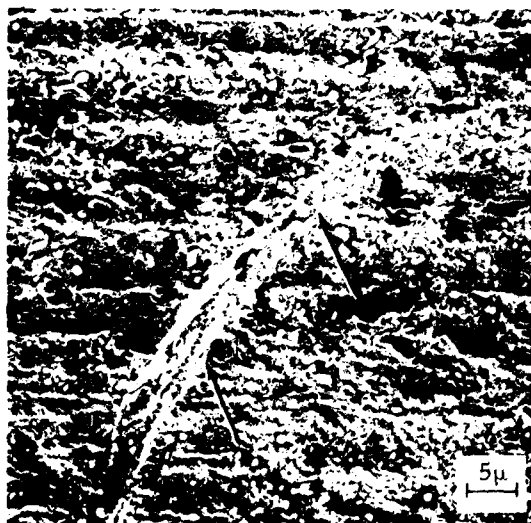
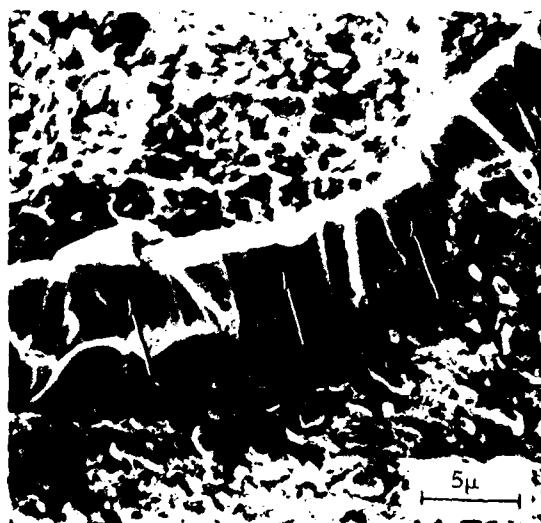
A. Surface Photomicrograph $\sim 100X$

B. Magnified View ($\sim 300X$) of Surface (SEM)
(after 2% nital etch)

C. Magnified View ($\sim 1500X$) of Region
a (SEM) (after 2% nital etch)

D. Magnified View ($\sim 3000X$) of Region b (SEM)
(after 2% nital etch)

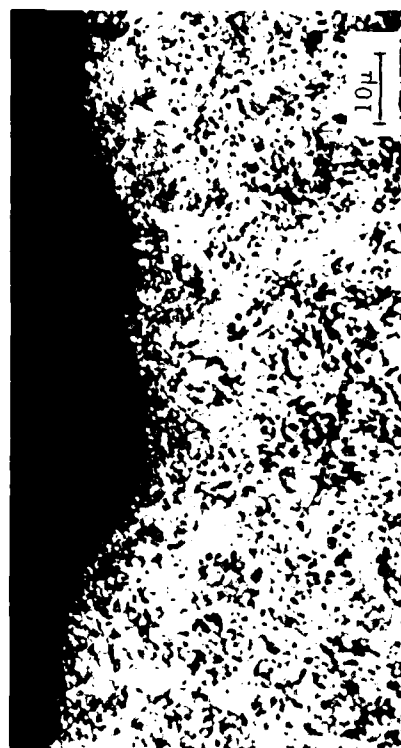
D. Section Plane 0.2916 ~1000X
(2% nital etch)

FIGURE F37. REPLICATION AND SECTIONING RESULTS FOR SURFACE INCLUSION PIT AT 0014-3314, J57-#4 BEARING (S/N 427C-1) INNER RACE S10141(3) (8337 hrs. after rework, repairable).

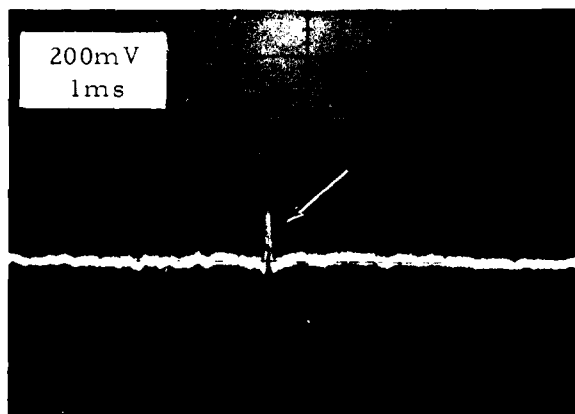
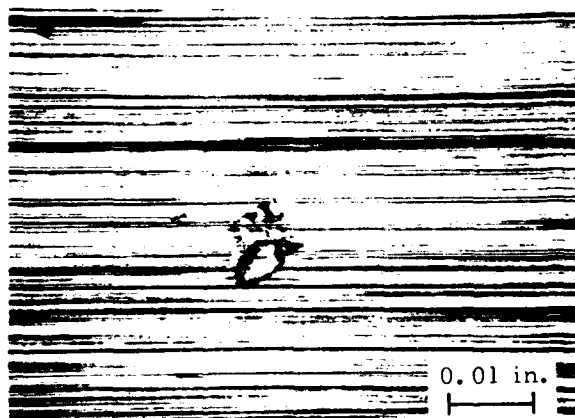
RH Signature @ 0011-2469

Magnified (50X) View of Surface @ 0011-2469

FIGURE F38. CIBLE RESULTS ON J57-#4 BEARING (S/N 7563-2) OUTER RACE S10992(5) (reworked bearing with 700 hrs. service - service prior to rework unknown).

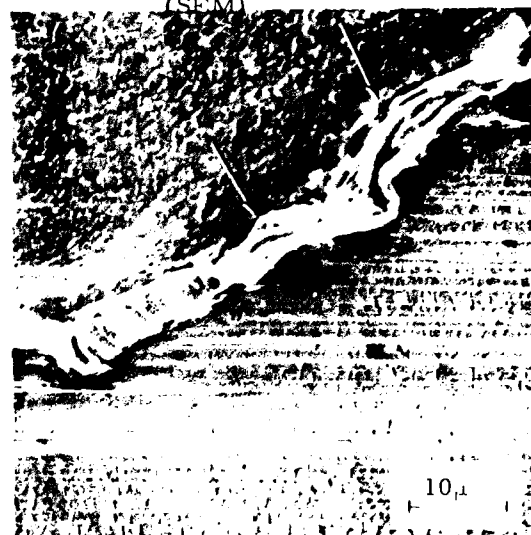
A. Optical Photomicrograph ($\sim 100X$)

B. Magnified View ($\sim 300X$) of Surface (SEM)

C. Magnified View ($\sim 1500X$) of Region a (SEM)

D. Magnified View ($\sim 1500X$) of Region b (SEM)

E. Magnified View ($\sim 1500X$) of Region c (SEM)

FIGURE F39. OPTICAL AND SEM PHOTOMICROGRAPHS OF SURFACE IMPERFECTION AT 0011-2469, J57-#4 BEARING (S/N 7563-2) OUTER RACE S10992(5) (Reworked + 700 hrs.).

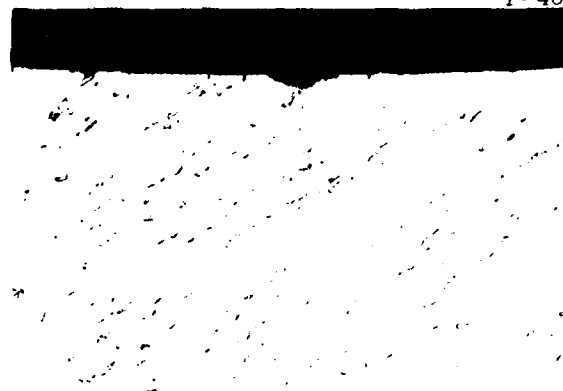
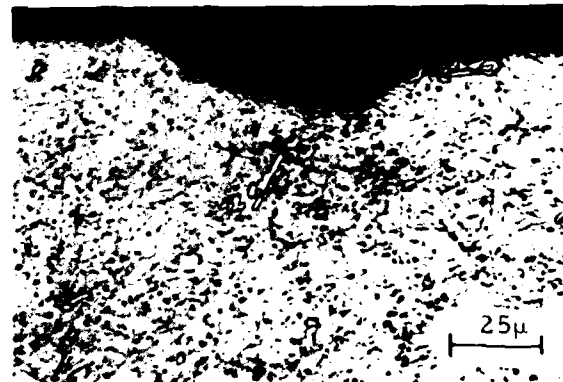
A. Radial Flux, High Field
Signature (© ST0006+16, BR4968)

D. Section Plane 0.4266 ~100X
(2% nital etch)

B. Surface Photomicrograph ~100X

E. Section Plane 0.4266 ~500X
(2% nital etch)

FIGURE F40. METALLURGICAL SECTIONING RESULTS FOR SURFACE IMPERFECTION
AT 0006-4968, J85-#2 BEARING (S/N 06498) INNER RACE
S31091(2) (time limited, 2851 hrs.).
